Docket No. 217 – Development and Management Plan Inspection

Northeast Utilities Service Company Certificate of Environmental Compatibility and Public Need for the construction of a 345-kV electric transmission line and reconstruction of an existing 115-kV electric transmission line between Connecticut Light and Power Company's Plumtree Substation in Bethel, through the towns of Redding, Weston, and Wilton, and to the Norwalk Substation in Norwalk, Connecticut.

Date: May 17, 2006

Location: 345kV Underground Route

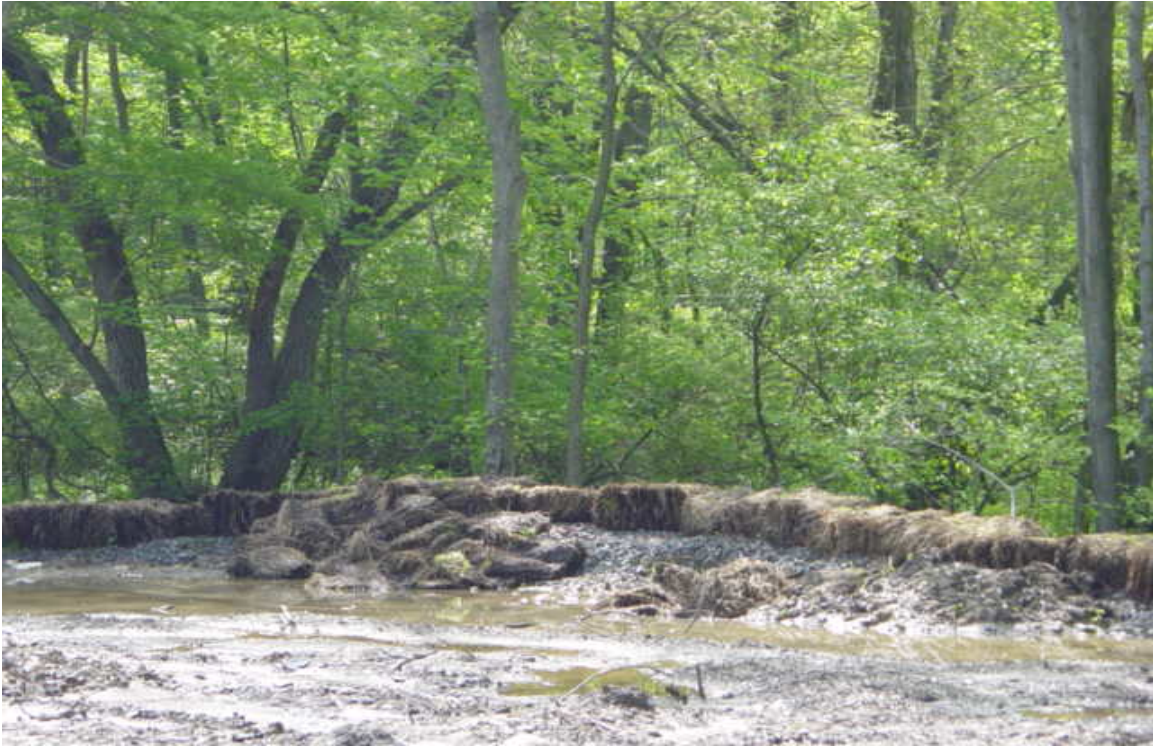
345kV (HDD) Photo shows an overall view of the basin and berm remaining at the HDD. This area is supposed to be graded soon. Haybales/controls are starting to deteriorate. 5/17/06

| Areas of Inspection | Observation | Recommended Action | Corrective Action |
|---|---|--|--|
| | - At the HDD, controls are degrading due to the additional rain and turbid water was noted getting under all the silt fence barriers. 5/17/06 | - Final restoration will occur in the near future as the basin will be graded and controls will be replaced. This needs to happen sooner than later. 5/10-5/17/06 | -Still needs attention, sooner than later |

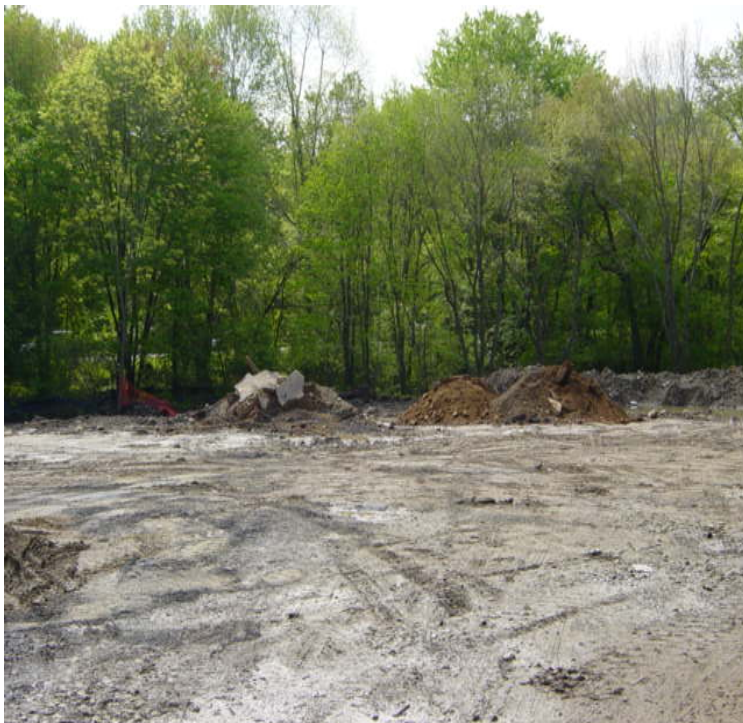
Photo on the left shows an overall view of the site which will be restored. Photo on the right shows where water was flowing to the silt fence and into the eastern wetland. It is unclear whether this was from on or off-site dewatering. 5/17/06

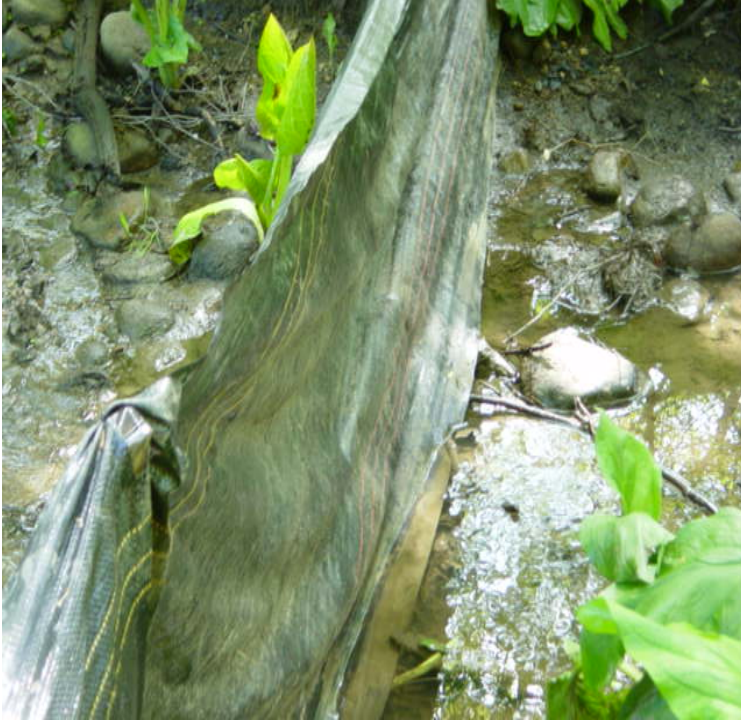
Photo on the left shows the water washing out under the silt fence. It was somewhat clear but picking up sediment from the site and previous deposits in the wetland. (Wilton HS J&B): Photo on the right shows the area adjacent to the stream. Vegetation is returning but spotty. 5/17/06

| Areas of Inspection | Observation | Recommended Action | Corrective Action |
|---|---|--|--|
| | -The combination of offsite dewatering and muds from the site led to sediment accumulation in the wetland to the east of the basin. 2/16-5/17/06 This increased further and water was noted washing under all of the silt fence barriers. 5/17/06 | -The accumulated sediment (over 6" in some areas) will need to be removed by hand to the extent feasible while attempting to avoid existing wetland vegetation. 5/10-5/17/06 All washed out controls need repair 5/17/06 | -This still needs attention and the condition has worsened |

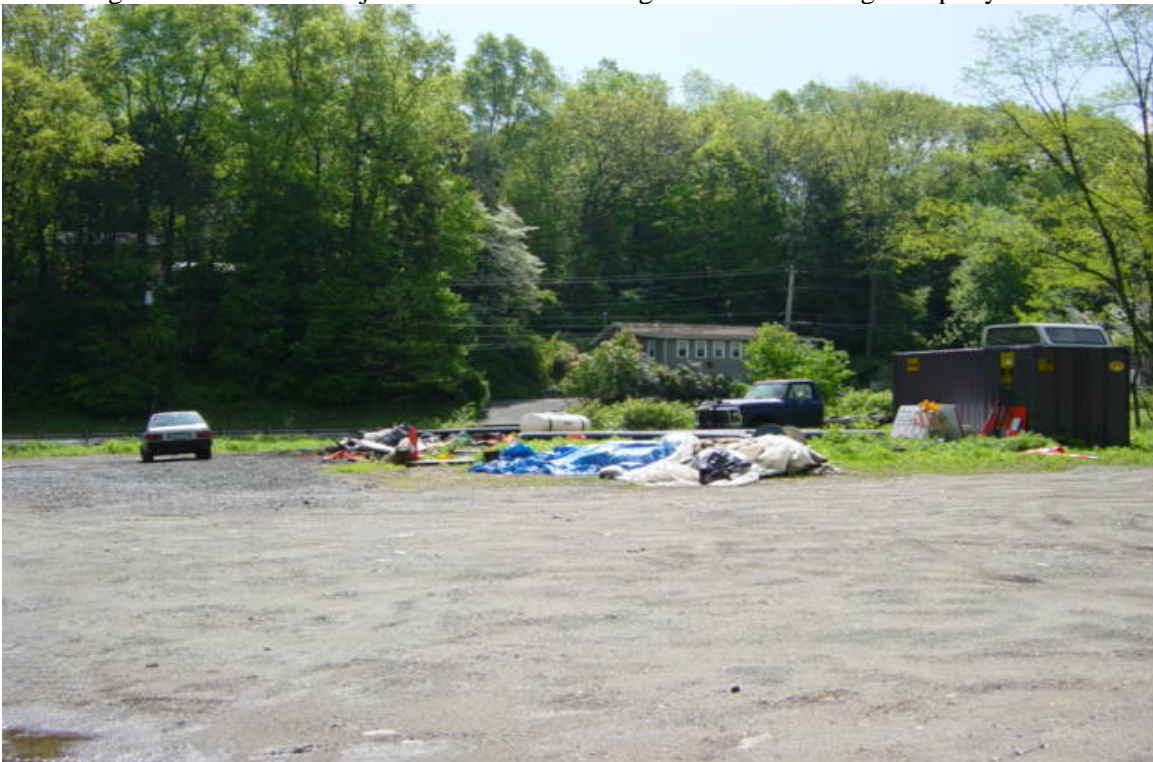
(Route 7) Photo shows the storage area which is contained but a debris pile remains here. Consider removing when feasible. 5/17/06

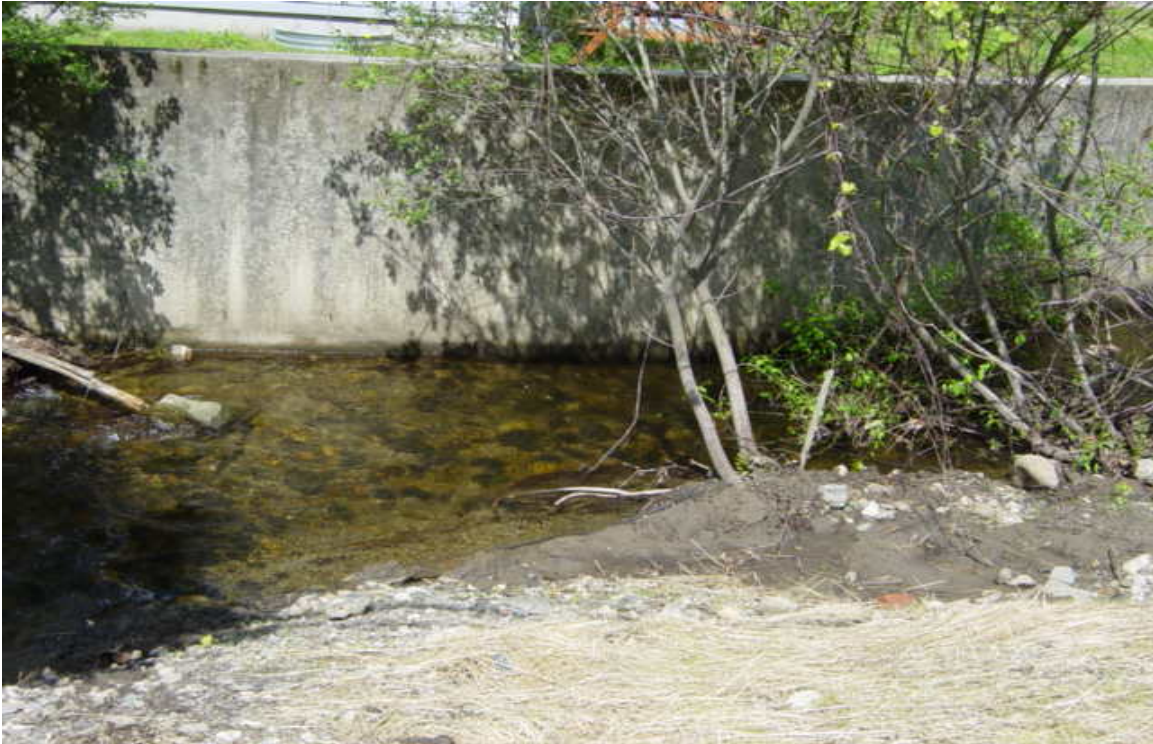
(Georgetown Deli): Photo shows the area at the base of the streambank that slumped in the heavy rains a few weeks ago. Silt fence was removed but EC mats were still recommended here. 5/17/06

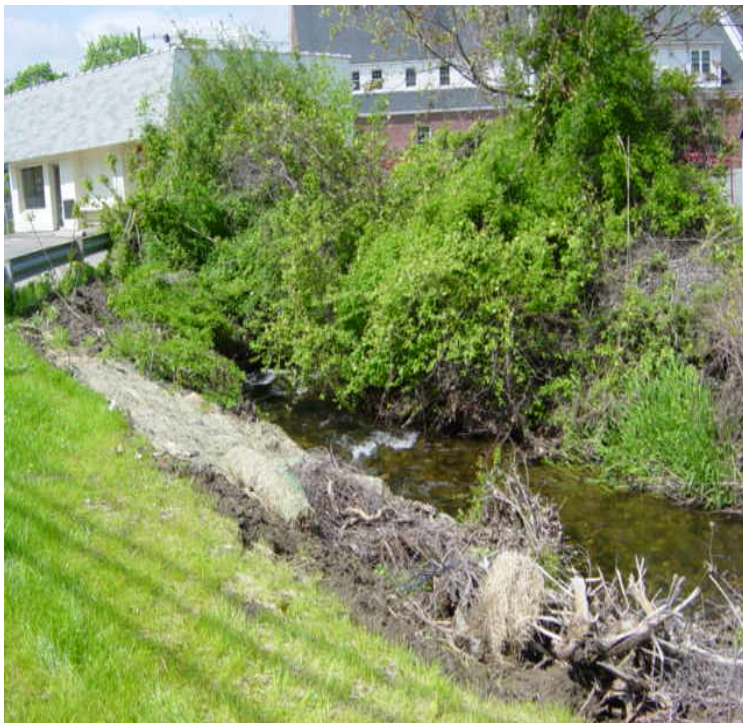
Photo on the left shows the bank just north of the deli. Silt fence was removed but the area of erosion still requires mats or further stabilization. Photo on the right shows where silt fence was removed further north. Boulders still need to be installed on the eroded spot along the slope.
